Product Information Bulletin

Slope Stabilization Using GeoSpec® Lightweight Fill Material

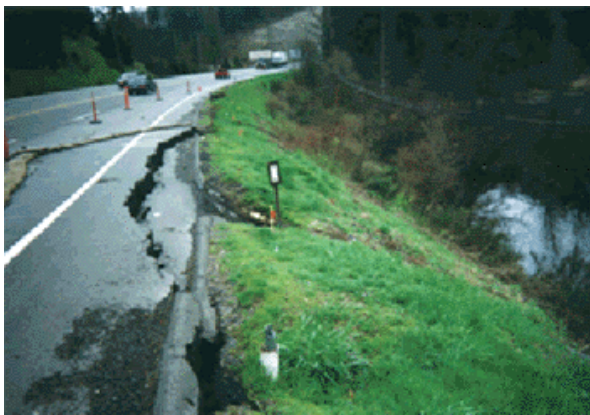
Figure 1 - Road Section Before Repair

The Province of BC, Ministry of Transportation and Highways, Nanaimo Office, sought a performance solution to reconstruct a section of highway, which had been subject to reoccurring side slope failure (Figure 1). This section of highway had been repaired unsuccessfully a number of times previously by filling and resurfacing the failed road section. In this instance, the side slope had failed resulting in a portion of the road surface dropping by up to 305 mm (12").

The Ministry sought a long-term performance solution to resolve the problem. The corrective measure taken was to excavate the section of road down to hardpan. GeoSpec lightweight fill material blocks were supplied to replace a portion of the failed soil embankment (Figure 2).

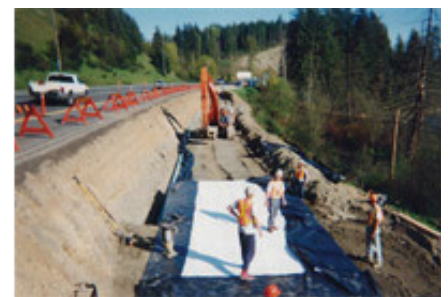
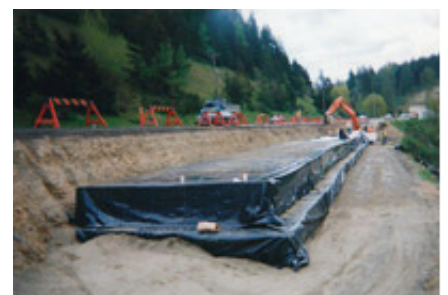
Figure 2 Installation of GeoSpec Lightweight fill Material

The blocks were delivered to the site on flat bed trailers, unloaded using a small bobcat, and then placed in their final position on the prepared roadbed by hand. The road construction crew backfilled over the GeoSpec blocks as they were placed.
