Product Information Bulletin

Slope Stabilization using GeoSpec® Lightweight Fill Material

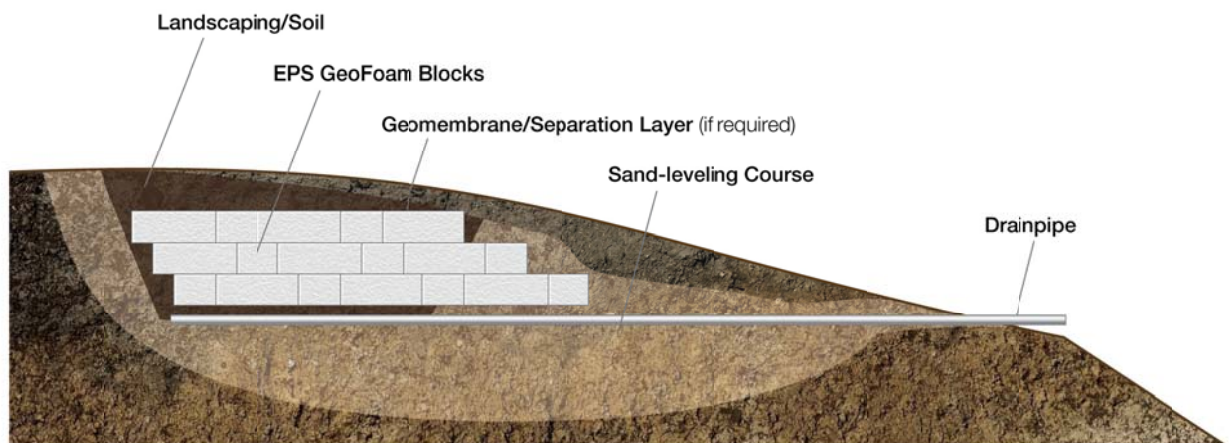
Figure 1 – EPS Geofoam Placement in Slope Stabilization Application

Geotechnical engineers recognize the validity of using expanded polystyrene (EPS) geofoam as lightweight fill to reduce mass and associated gravitational driving forces within sloped embankments. The detail below illustrates a typical slope stabilization application using GeoSpec® lightweight fill material. GeoSpec EPS geofoam with a density from 20 to 40 kg/m³ is up to 100 times lighter than in-place soil with a typical density of 2,100 kg/m³. This means that replacing in-place soil in an unstable slope with EPS geofoam can achieve a significant net reduction in driving force within the embankment.

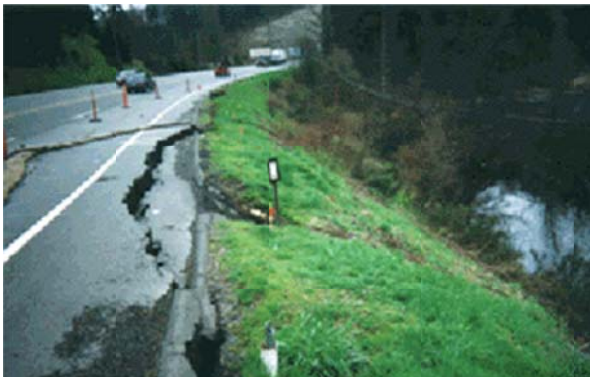
The Province of BC, Ministry of Transportation and Highways, Nanaimo Office, sought a performance solution to reconstruct a section of highway, which had been subject to reoccurring side slope failure (Figure 2). This section of highway had been repaired unsuccessfully a number of times previously by filling and resurfacing the failed road section. In this instance, the side slope had failed resulting in a portion of the road surface dropping by up to 305 mm (12").

#1 near Duncan, BC on Vancouver Island. The close proximity of the lake was seen to increase the likelihood of the side slope failure reoccurring.

When side slope failure occurs in road applications, it is often the result of subsurface soil with low load-bearing capabilities. Often in this type of situation makeshift repairs are implemented by filling and resurfacing the failed road section.

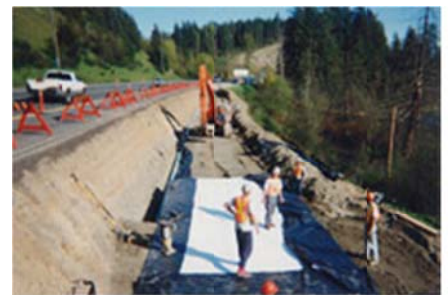
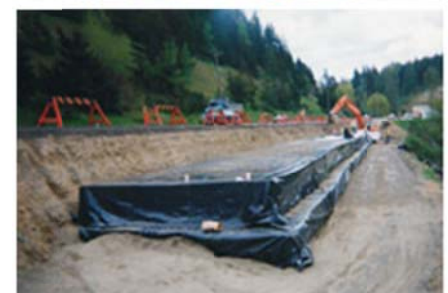
Figure 3 - Installation of GeoSpec Lightweight fill Material

To provide an improved slope safety factor against failure, the Ministry sought a long-term performance solution to resolve the problem. The corrective measure taken was to excavate the section of road down to hardpan. GeoSpec lightweight fill material blocks were supplied to replace a portion of the failed soil embankment (Figure 3).

The blocks were delivered to the site on flat bed trailers, unloaded using a small bobcat and then placed in their final position on the prepared roadbed by hand. The road construction crew backfilled over the GeoSpec lightweight fill material as they were placed.

GeoSpec lightweight fill material has a density of about 1 to 2% of soil or rock, yet it has sufficient strength to support typical loads encountered in highway construction applications. With construction complete, the load on the subsoil has been greatly reduced and the likelihood of future maintenance issues has been reduced.
